Re: May 2017 Monthly Progress Report
Administrative Settlement Agreement and Order on Consent for Removal Action
U.S. EPA Region 10 Docket No. CERCLA 10-2009-0255
Gasco Sediments Site within the Portland Harbor Superfund Site

Attachment A Monthly Visual Monitoring Report for Pilot Cap Vicinity

Visual Observations Log Form

Project: NW Natural – Gasco

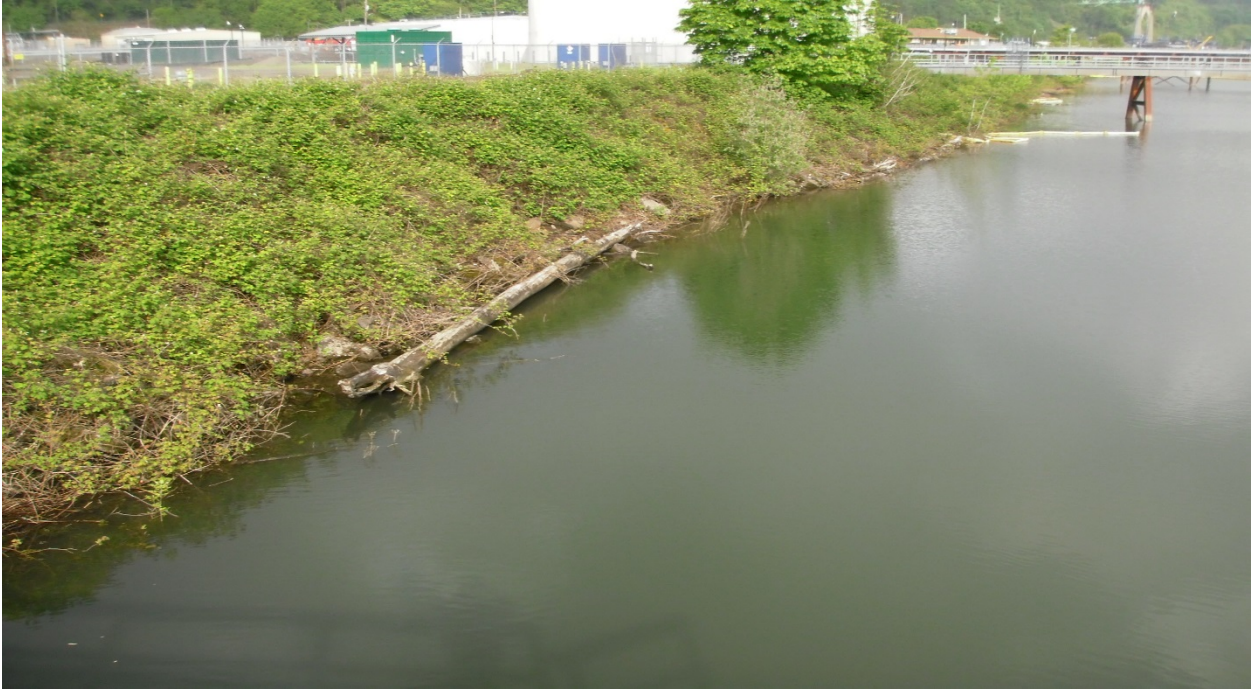
Photo 1

No erosion/deposition is evident along the shoreline. The shoreward extent of the cap was not visible due to high river water elevation and the organoclay mat material shoreward of the cap area could not be observed (Photo 1).

River Level Currently Above the Extent of Sediment Cap (5/15/2017)

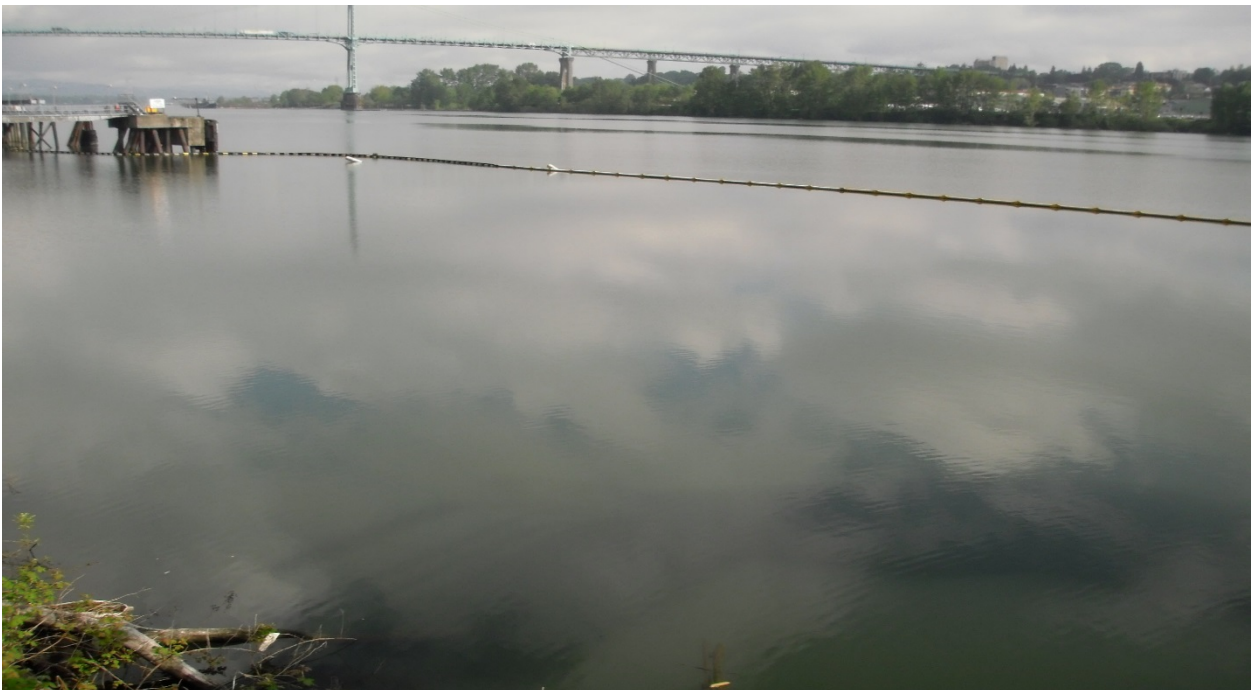
Photo 2

During the observation, the Pacific Terminals containment boom was placed across the cap area from the ship dock to the upriver dolphin. Two buoys that identify the cap area to mariners are in place as installed. The positions of the Pacific Terminals oil boom and warning buoys are shown in Photo 2.

FAMM Oil Boom Placement and Mariner Warning Buoys at Pilot Cap Area (5/15/2017)

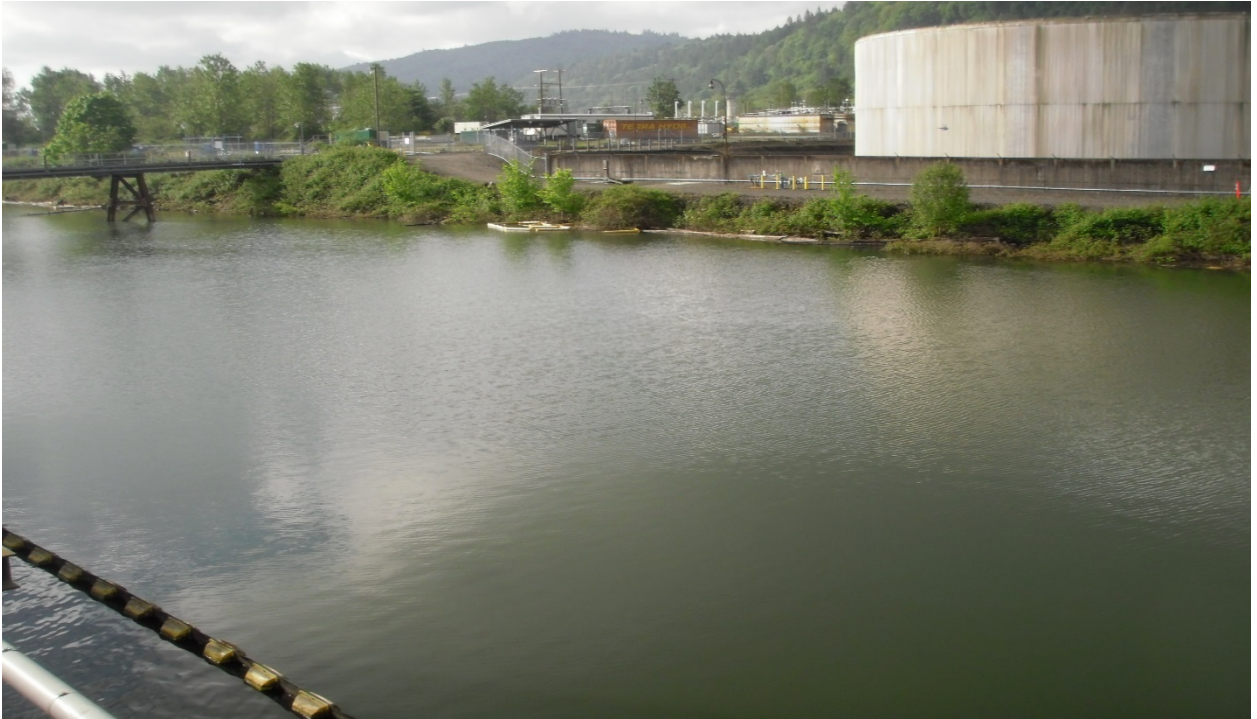
No sheen is evident in or around the cap area. Photo 3 shows the water surface and shoreline immediately downriver of the sediment cap.

Photo 3
Conditions Immediately Downriver of Cap Area (5/15/17)
